DEPARTMENT OF TRANSPORTATION**DIVISION OF ENGINEERING SERVICES**

Contract #: 04-0120F4Cty: SF/ALA Rte: 80 PM: 13.2/13.9File #: 1.28**WELDING INSPECTION REPORT****Resident Engineer:** Pursell, Gary**Address:** 333 Burma Road**City:** Oakland, CA 94607**Report No:** WIR-015757**Date Inspected:** 20-Jul-2010**Project Name:** SAS Superstructure**OSM Arrival Time:** 1000**Prime Contractor:** American Bridge/Fluor Enterprises, a JV**OSM Departure Time:** 1830**Contractor:** American Bridge/Fluor Enterprises, a JV**Location:** Job Site

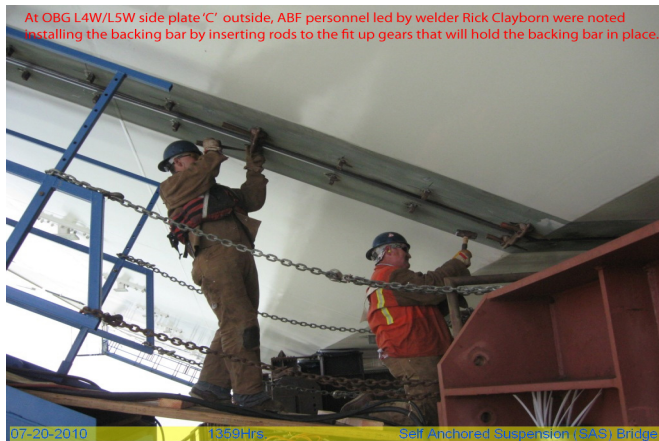
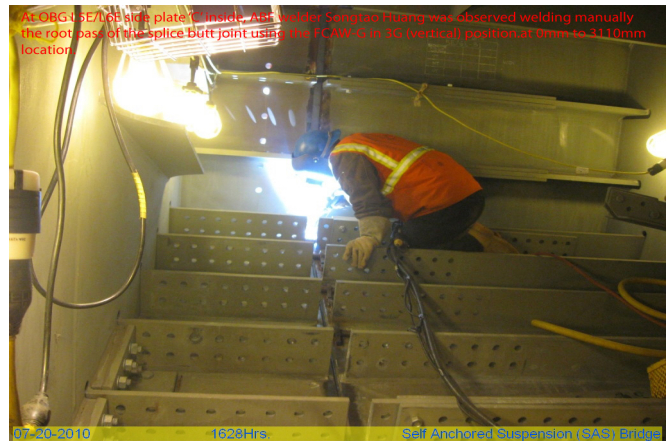
At OBG L4W/L5W side plate 'C' outside, QA randomly observed ABF welder Rick Clayborn perform tack welding of 42 pieces of fit up gear/temporary attachment to be used as an aid in the installation of the backing bar. The welder was using Shielded Metal Arc Welding (SMAW) with 1/8" diameter E7018H4R electrode. During the shift, the welder has completed the welding of the fit up gears/temporary attachment and installed the backing bar from the outside. The welder and QC have moved inside the OBG and started measuring the fit up alignment.

With the completion of the installation of the backing bar from the outside of OBG L4W/L5W side plate 'C', the ABF QC William Sherwood was noted inside the OBG measuring the alignment of the splice butt joint. The welder was also noted adjusting the alignment by hammering the rods inserted to the fitting gears from the outside. According to QC, although his measurement was still in progress, he found the partially measured fit up alignment of the splice deemed within the contract requirements.
